ANNUAL REPORT FOR 2002

**Mildred Woods Mitigation Site
Edgecombe County
Project No. 6.09902T
TIP No. R-2111/R-2112A**

Office of Natural Environment & Roadside Environmental Unit
North Carolina Department of Transportation
December 2002/March 2003 (Revised)

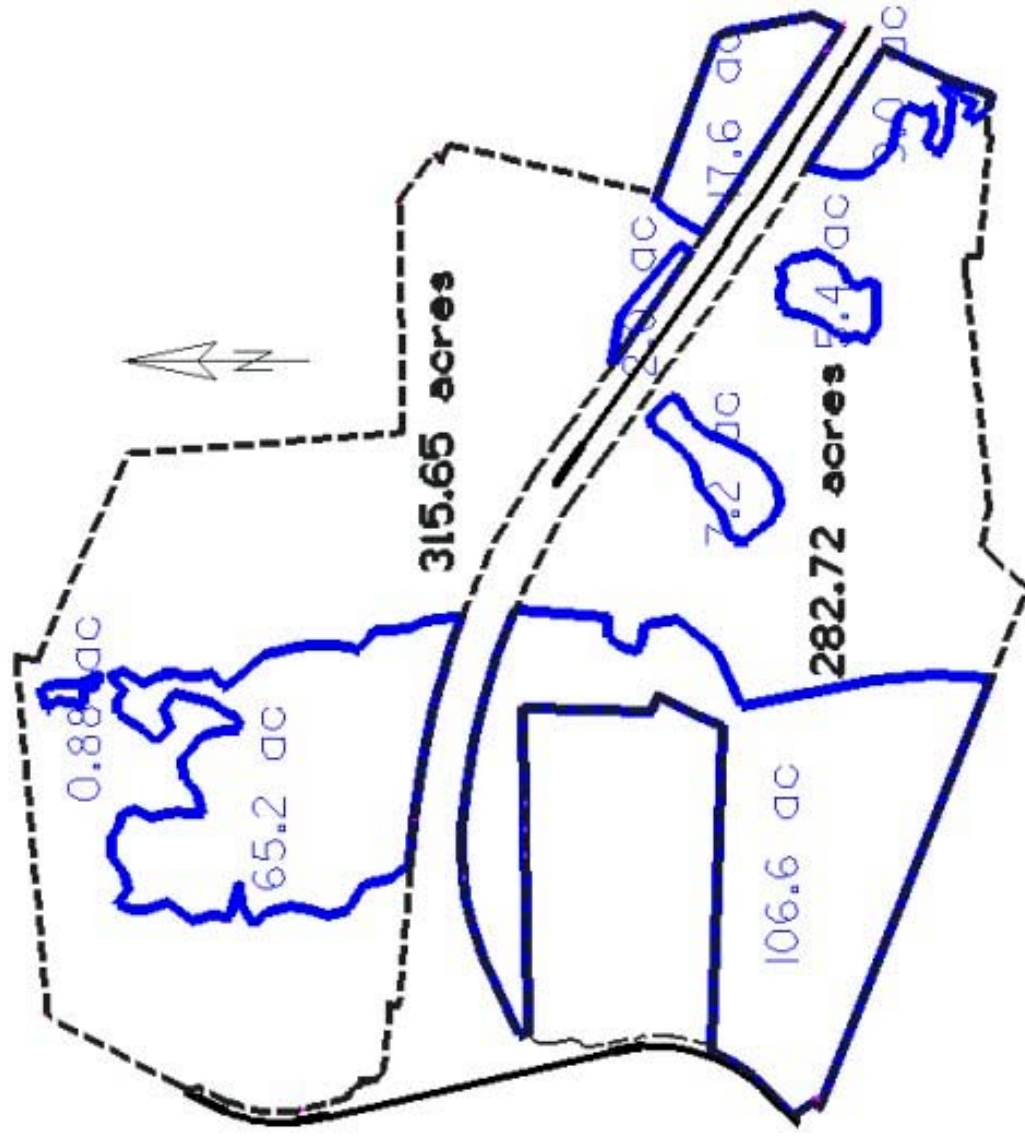
Figure 2. Mildred Woods Delineation Map (sections shown to be dry noted in blue, with acreage)

Table 1 is the current debit ledger for the Mildred Woods Site. The new delineation map (Figure 2) was used to update the acreage of wetlands delineated, uplands, and wetland acreage debited for roadway projects. Table 2 summarizes the total acreage of the dry areas; these are not included in the debited area of the site.

Section (Corresponding to Placed Gauges)	New Upland Acreage
2	65.2
2	0.88
5	2.0
5	17.6
3,10	106.6
4	7.2
4	5.4
8	9.0
Total Upland Acreage	213.9
Total Wet Acreage (593 Ac Total-Upland)	379.1

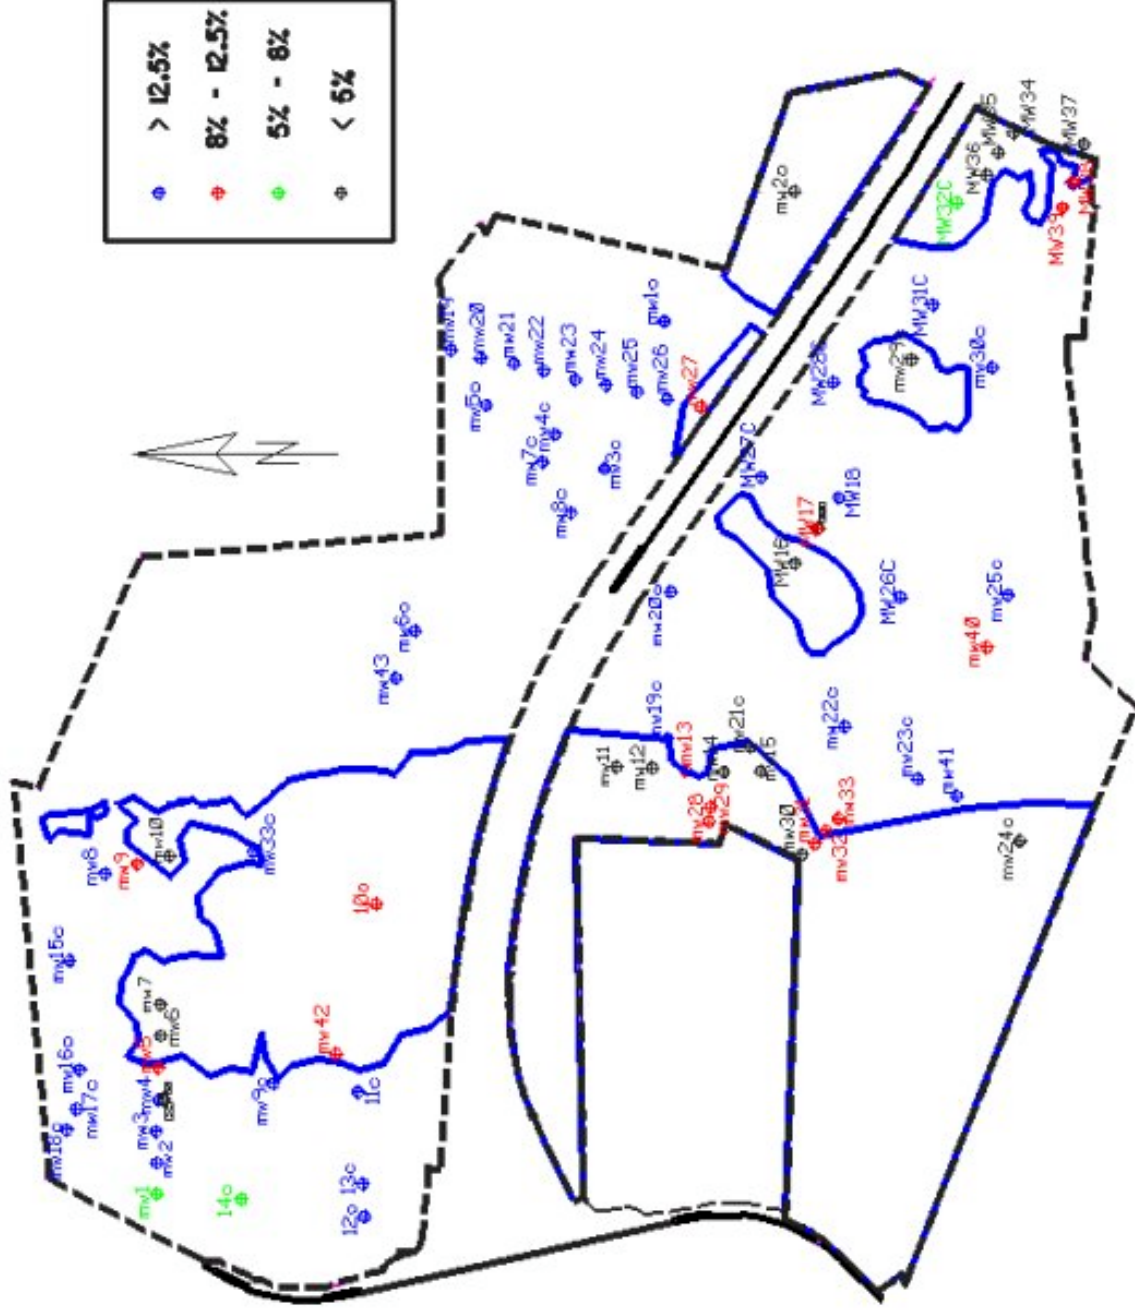
Figure 4. Hydrologic Monitoring Results 2002

Figure 4 is a graphical representation of the 2002 hydrologic results.

Of the 76 gauges currently on the site, 53 gauges either met or exceeded their respective hydrologic expectations during a year with average rainfall. Most of the gauges that did not meet the hydrologic expectations for the 2002 growing season are either located adjacent to the borrow pits or within the center area of the site.

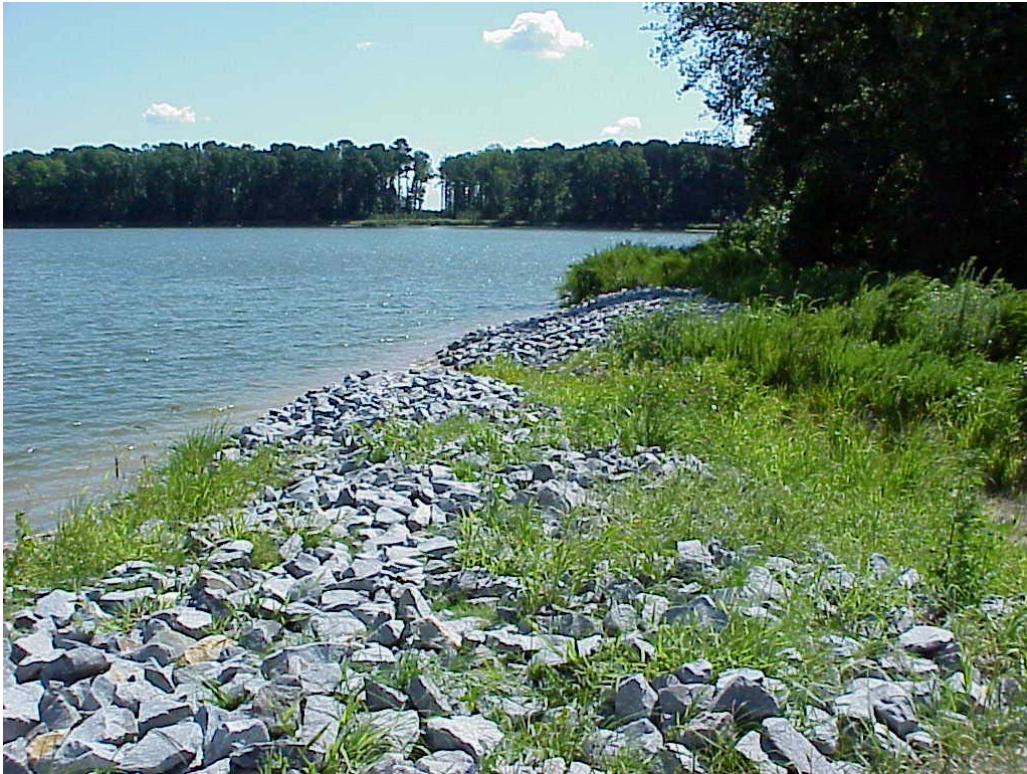
Instead, the Department proposed to stabilize the entrance of the outlet ditch using class-B rip-rap and filter fabric. Because of the minimal length of rip-rap, this activity was covered under Nationwide Permit 13 (Bank Stabilization) and requires that the Department notify the U.S. Army Corps of the Engineers upon successful completion of the activity. The NCDOT

Edgecombe County Maintenance Forces completed this work on mid June 2002. (See attachment photo documentation)

Northeast at entrance to outlet.

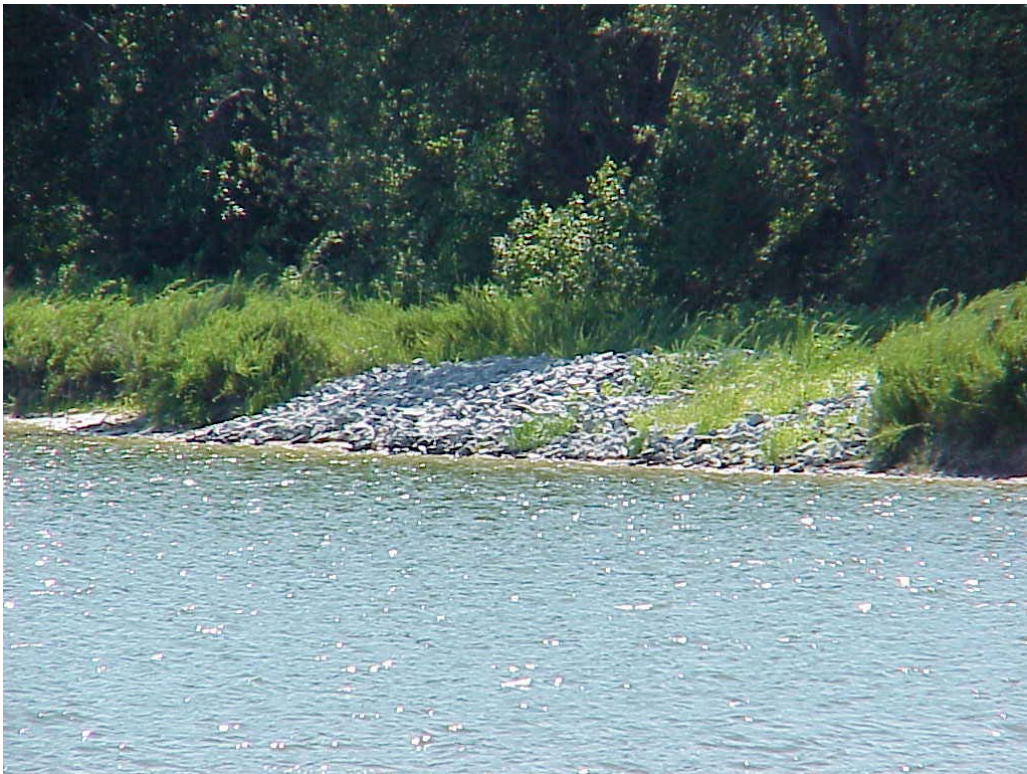
Southwest across Borrow Pond towards outlet ditch.
